TORNADO PROTECTION

SELECTING and DESIGNING SAFE AREAS in BUILDINGS

TR-83B / DEFENSE CIVIL PREPAREDNESS AGENCY / APRIL 1976

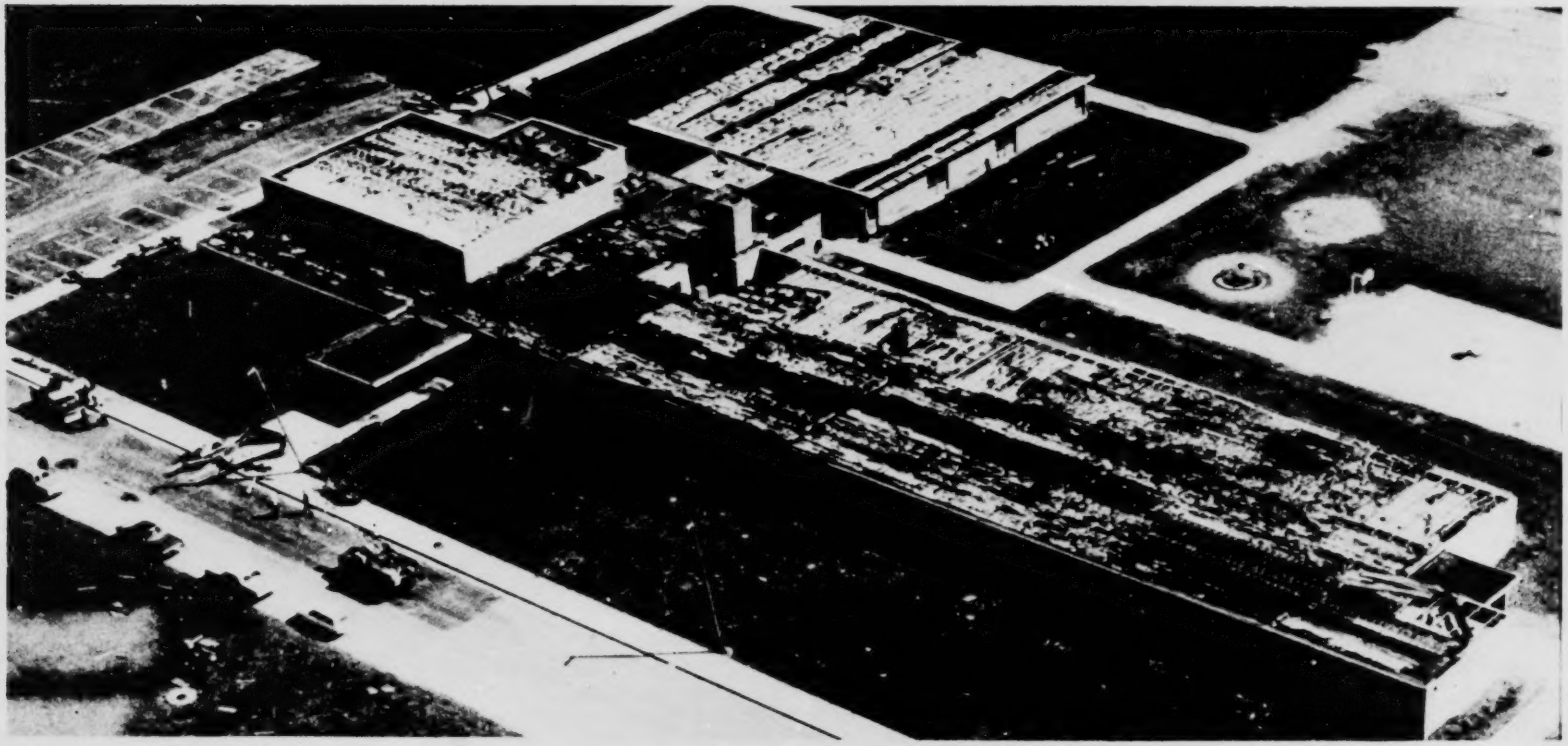
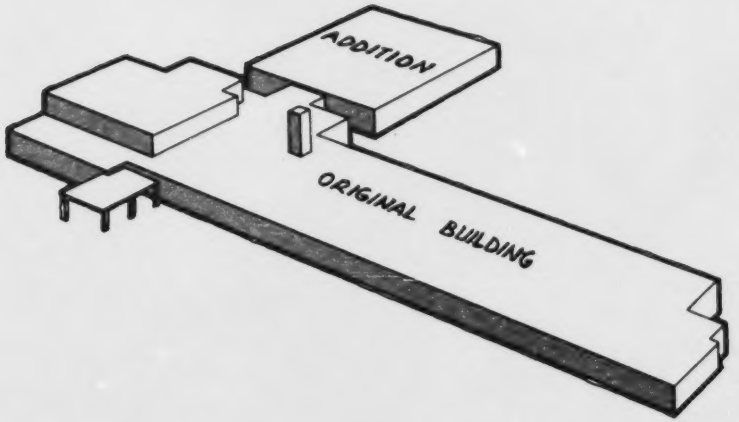
MEADOWLAWN ELEMENTARY SCHOOL

Unrepairable damage occurred to the original classroom wing when the south exterior walls failed. The *WINDOWS* blew into all of the *WINDWARD SIDE* classrooms. All south and west windows were broken. Wind entering these rooms caused a ballooning effect. Some of the metal roof deck was lifted, and was scattered through an open field northeast of the school.

The original 12 classrooms and library were demolished. The boiler room, multipurpose room, offices, and the six-classroom addition were repairable.

North and east classrooms received little damage.

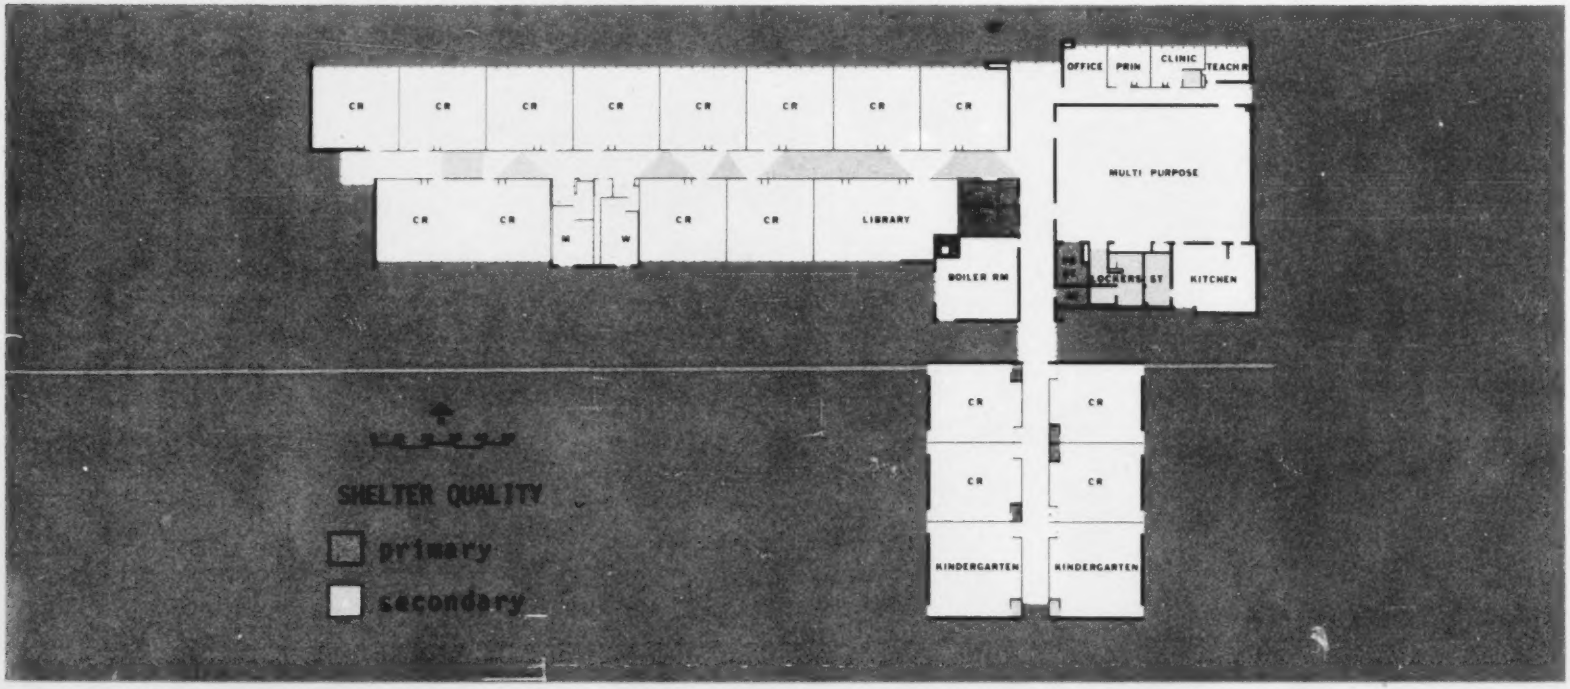
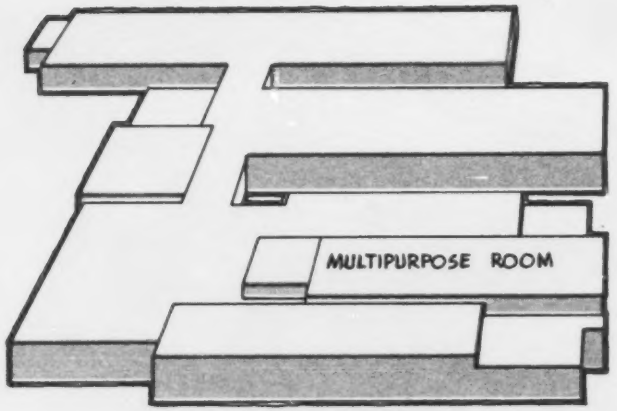
MONROE CENTRAL SCHOOL

The building was so badly damaged it was deemed a total loss and later was completely demolished.

The tornado center passed slightly to the right of the center of the building, and caused major damage to all three wings. The enclosure walls failed, allowing the winds to enter interior spaces, lift roofs, and toss debris throughout the building.

Winds entering the room caused a ballooning effect. The lightweight roof deck was blown off. Some of the deck and the steel bulb tees fell on the floor; and the remainder blew onto adjacent roofs and open spaces.

The winds blew into the building from the south and east. The *WINDWARD* (east) *GLASS CURTAIN WALLS* blew in, allowing a ballooning effect, which caused the *LOAD-BEARING* end walls to blow out. The precast concrete roof planks were lifted up. Some fell back into the rooms, and others blew on top of the remaining roof. The north-south corridors became *WIND TUNNELS* throughout their entire length.

The completely *INTERIOR SPACES* remained intact, offering protection against incoming missiles such as glass, brick, gravel, and block. This was particularly true of the *SHORT SPANS* or smaller spaces such as toilet rooms, work rooms, and storage spaces. Rooms on the leeward (north) side received least damage. Only one north window was broken. The *STRUCTURAL FRAME* remained intact. However, the roof deck was not rigidly connected to these frames, and for the most part depended upon their weight to resist wind uplift. The *HEAVY CONCRETE ROOF* remained intact over most of the building.

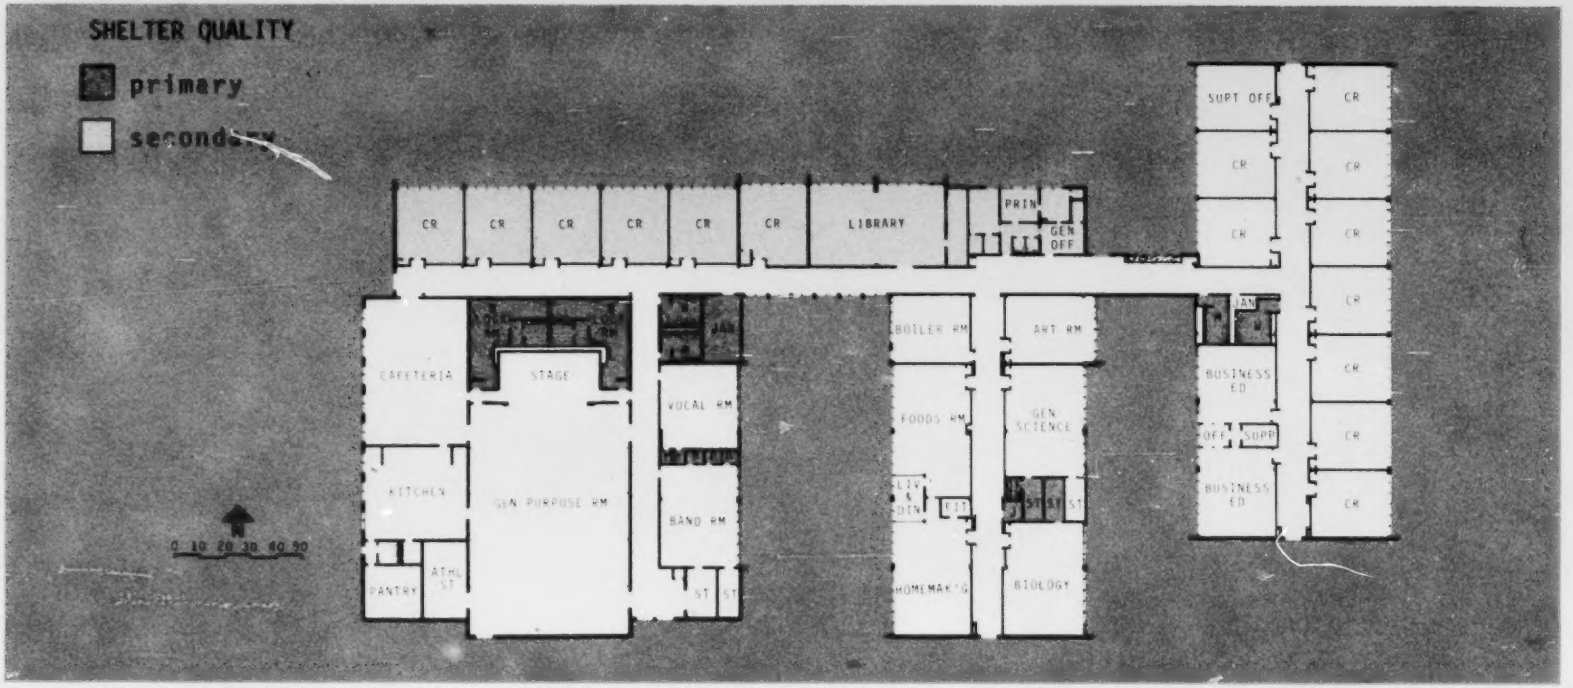
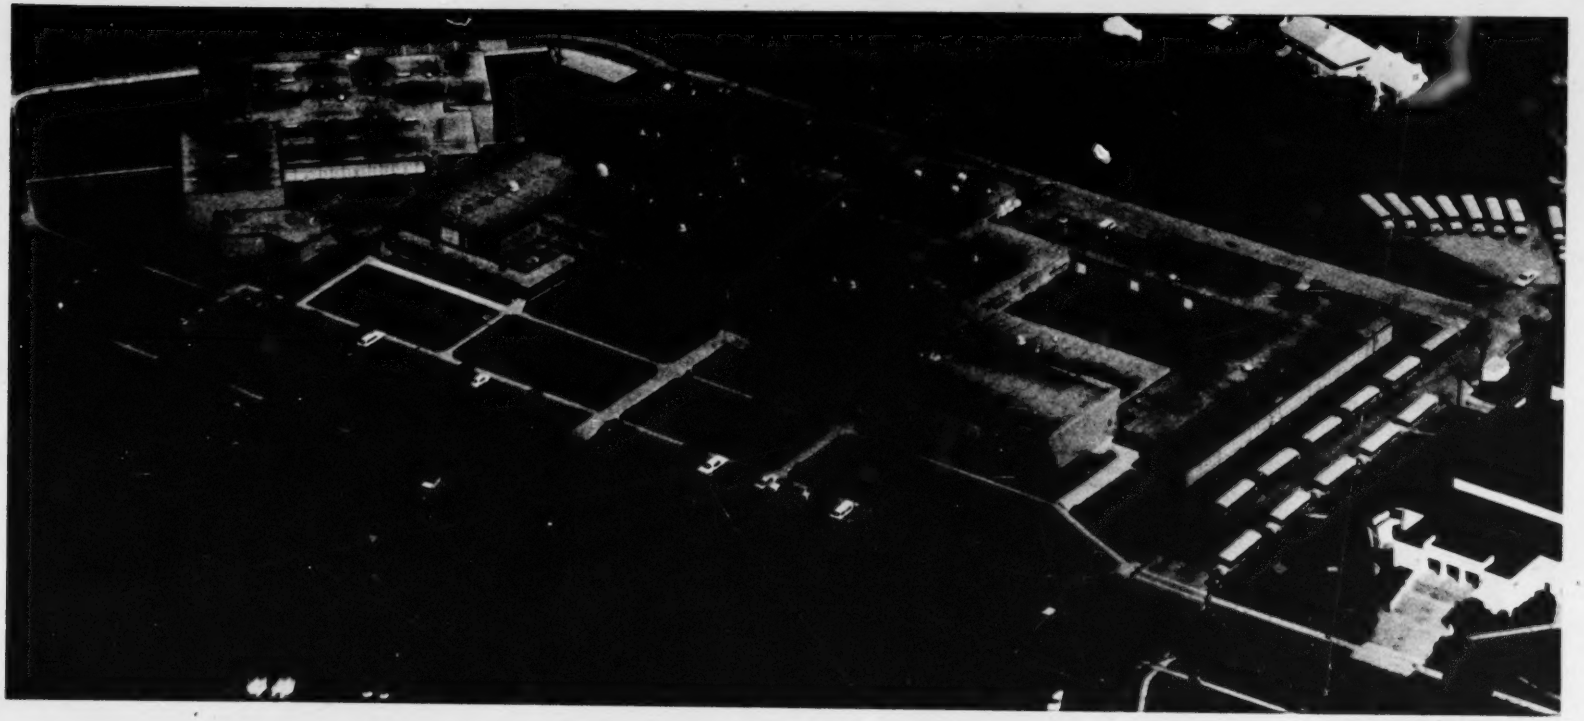
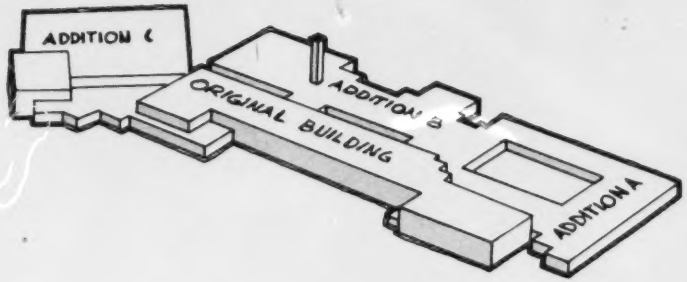
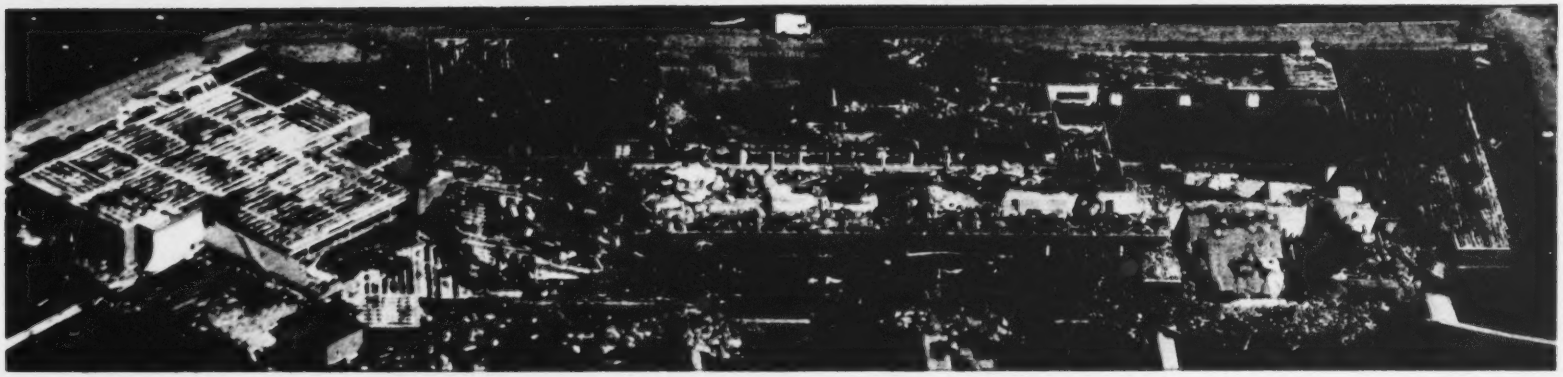
XENIA SENIOR HIGH SCHOOL

The tornado passed directly over the school. Two school buses came to rest on the stage where the students had been rehearsing. Some of the students were treated at a nearby hospital for injuries.

The building was unsafe to enter and was demolished.

The tornado passed directly over the school. It engulfed the entire building, plus the adjacent fieldhouse to the south.

The enclosure walls failed on the west and south sides, allowing the winds to enter the building. The roofs collapsed over the three large spans—the auditorium, the boys' gym, and girls' gym. The lightweight roof over the original two-story building was removed.

All *WINDOWS* on the *WINDWARD SIDES* (west and south) were blown into the interior. The high single-story, *LOADBEARING MASONRY WALLS* of the *LONG-SPAN* rooms failed, allowing the roofs to fall in. The unbaffled west entrances allowed the east-west corridors to become *WIND TUNNELS*.
